PV BACKSHEET FAILURE ANALYSIS BY SCANNING ACOUSTIC MICROSCOPY

Djamel Eddine Mansour, Sandra Kotterer, Daniel Philipp, Paul Gebhardt
Fraunhofer Institute for Solar Energy Systems ISE
Heidenhofstrasse 2, 79110 Freiburg im Breisgau, Germany
T: +49 761 4588-5880
djamel.eddine.mansour@ise.fraunhofer.de
<https://www.ise.fraunhofer.de>

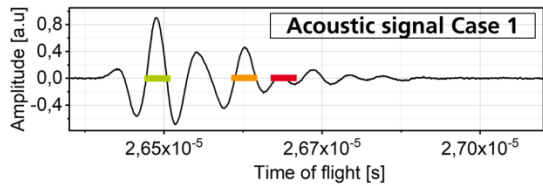
Figure 4 represents the reflectogram of the PV module (case 1) measured from the rear side (BS) in the intercellular gaps. The acoustic beam is focused at the BS surface (first peak on the left). The assignment of the signals was done based on the knowledge on the present interfaces in the module [8]. The strongest peak on the left at 2.65 μ s TOF corresponds to the water/BS surface (outer layer in green in Figure 4), the following gates are assumed to correspond to the core/inner layers interface (orange) and the inner/encapsulant interface (red).

Figure 4 TOF-amplitude reflectogram of a PV module case 1

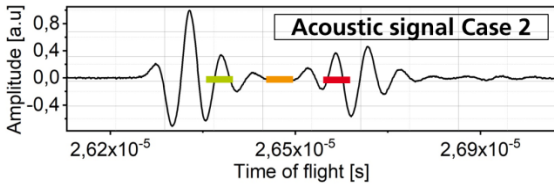
Figure 5 TOF-amplitude reflectogram of a PV module case 2

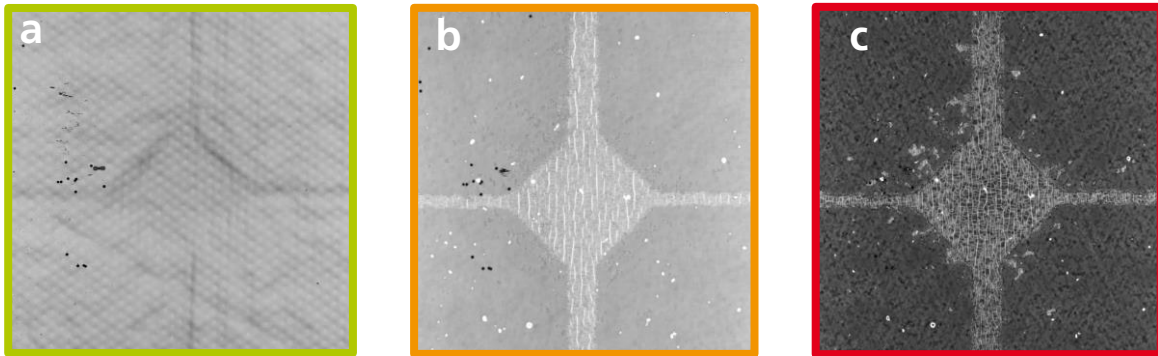
The backsheet of the Module case 1 could be identified to consist of a fluoropolymer coating (outer layer), polyethylene terephthalate (PET) (core layer) and a damaged polypropylene (PP) (inner layer) as shown in **Fehler! Verweisquelle konnte nicht gefunden werden.** This backsheet had previously been inspected visually and no BS-cracking had been observed of the module.

As observed in the visual inspection, the weathered backsheet outer layer has an intact surface (echo (a) Figure 6) between and behind the cells. Inside the backsheet and only between cells, cracks in one direction are observed at the core/inner layers interface (echo (b) Figure 6). Deeper inside the inner layer, additional smaller cracks in multiple directions are visible (echo (c) Figure 6).

Figure 6 SAM images of Case 1: a. outer layer surface; b. core/inner layers interface; c. inner layer bulk

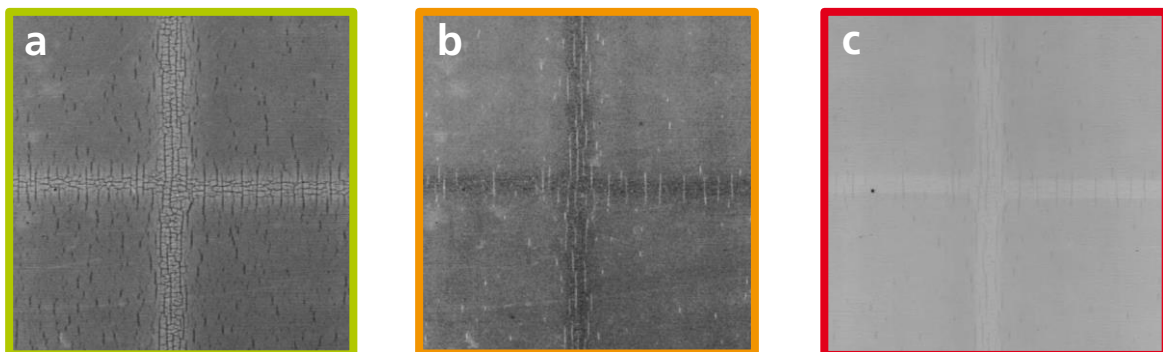
The second type (case 2) of the PV-field aged module (**Fehler! Verweisquelle konnte nicht gefunden werden.**) contained a backsheet consisting of a PET core layer sandwiched by two PA layers. By placing three gates in reflectogram in Figure 5, the acoustic images in the Figure 7 were obtained at specific corresponding acoustic depths inside the multilayered backsheet. At the outer PA/core PET layers interface, both cracks in the machine direction can be observed. These are especially pronounced in the cell gap locations, where additional, smaller cracks in different directions are present (echo (a) Figure 7). All cracks are difficult to see with the naked eye (almost not visible). The corresponding acoustic image of echo (b) Figure 7 shows larger cracks in a gate

(b) that is assigned to the bulk of the PET core layer. The cracks appear with high contrast since no interface was detected in this region (no peak reflectogram, Figure 5). The last image at echo c, Figure 7, represents the core/inner layers interface.

Both cases of backsheet cracking presented earlier are observed only along the intercellular spacing where the front UV irradiation can be absorbed during operation. The structure of these cracks can be clearly visualized and quantified by SAM analysis. In case 2 both cracking types mainly affect the outer PA layer and the Inner PET layer. However in case 1, both crack types are visible at the inner/EVA layer interface. In a previous study, similar cracks were accompanied by a delamination of the inner PA-layer from one of the adjacent layers[3].

Figure 7 SAM images of Case 2: a. outer/core layers interface; b. core layer bulk; c. core/inner layer interface

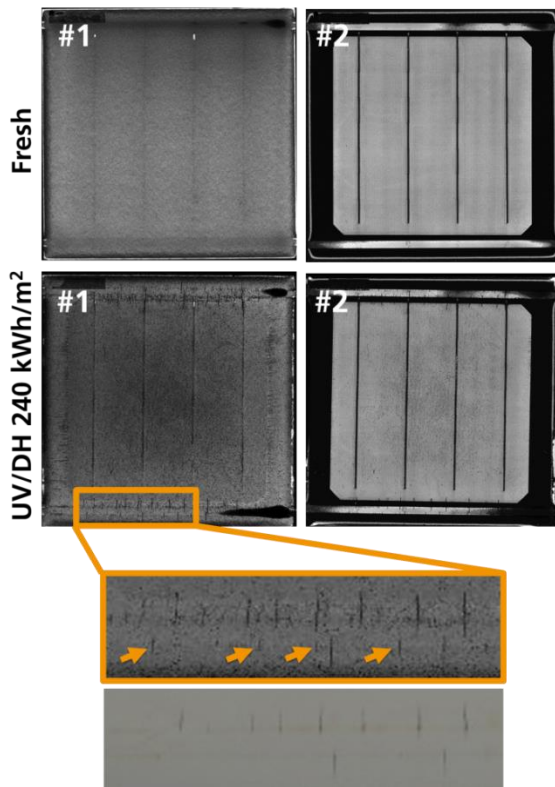
However, outer layer field cracks, similar to case 2, were obtained after a 240 kWh/m² UV irradiation; elevated temperature and elevated relative humidity were combined in the aging tests (UV/DH). This acknowledges that moisture plays a synergistic role with UV in the formation of surface backsheet cracking [4,6]. The same failures have been also recently reproduced by an indoor accelerated aging test utilizing simultaneous combined stresses (UV, humidity, temperature and

Acoustic images in the Figure 8 were taken by applying gates to peaks (#1) and (#2) as indicated in Figure 9, before and after a UV/DH combined accelerated aging test. The acoustic beam can be focused to increase the amplitude of specific signals and thereby increase the image quality for a chosen interface. The images at echo #2 show the main elements at the back surface of the cell, such as the back ribbons and cross-connector. Naked eye visual and additional non-visual cracks (orange arrows) are detected with SAM image after the aging test.

Figure 8 Acoustic micrographs of mini-module 2 before (top) and after UV/DH combined aging test (bottom) at the BS (#1) (left) and cell interface (#2) (right)
