PV BACKSHEET FAILURE ANALYSIS BY SCANNING ACOUSTIC MICROSCOPY

Djamel Eddine Mansour, Sandra Kotterer, Daniel Philipp, Paul Gebhardt
Fraunhofer Institute for Solar Energy Systems ISE
Heidenhofstrasse 2, 79110 Freiburg im Breisgau, Germany
T: +49 761 4588-5880
djamel.eddine.mansour@ise.fraunhofer.de
<https://www.ise.fraunhofer.de>

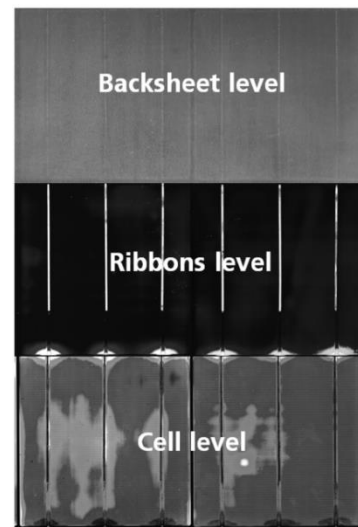
The acoustic micrographs in Figure 3 were generated from specific gates in the reflectogram, representing different depths inside the fielded PV module. This is desired if individual interfaces between the PV components are inspected. For example, using one SAM scan, three micrographs can be generated: (top image) Backsheet/encapsulant interface, (middle image) ribbons of the backside of the cells. Therefore, the image looks darker and (bottom image) encapsulant/cells interface. Here, the ribbons and silver pads at both sides of the cells are visible.

Figure 3 Acoustic micrographs (SAM images) generated from the different spectral regions ("gates") from a full-size module.

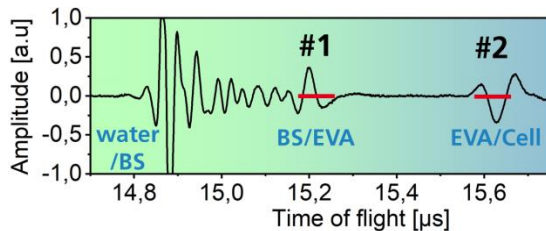
Acoustic images in the Figure 8 were taken by applying gates to peaks (#1) and (#2) as indicated in Figure 9, before and after a UV/DH combined accelerated aging test. The acoustic beam can be focused to increase the amplitude of specific signals and thereby increase the image quality for a chosen interface. The images at echo #2 show the main elements at the back surface of the cell, such as the back ribbons and cross-connector. Naked eye visual and additional non-visual cracks (orange arrows) are detected with SAM image after the aging test.

Figure 9 TOF-amplitude reflectogram of a PV mini-module measured at 30 MHz
